GM Steering Upgrade Kit

Upgrade Tie Rods and Center link for 2001-2010 GM Trucks

1032150	2001-2010 GM Steering Kit
----------------	----------------------------------

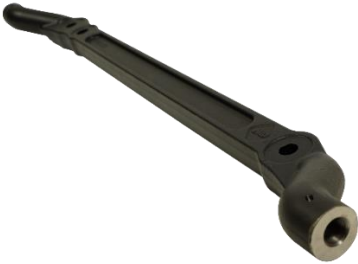
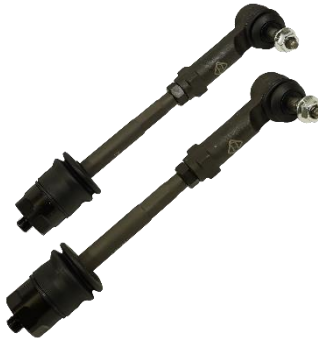
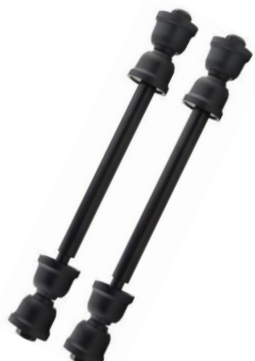
1302123-CK	1302125	FT-0496013	1302126

Center Link Qty: 1	Tie Rod Assembly Qty: 2	Grease Fitting Qty: 2	End Link Qty: 2
