## TROUBLESHOOTING GUIDE

**SUBJECT: LML Duramax CP3 Conversion Kit**

FPE-2024-124  
May, 2024  
Page 1 of 9

**FITMENT:** 2011-2016 GMC Sierra and Chevrolet Silverado 2500/3500 equipped with 6.6L LML Duramax  
**KIT P/N:** FPE-LML-CP3-NP, FPE-LML-CP3-WP, FPE-LML-CP3-10

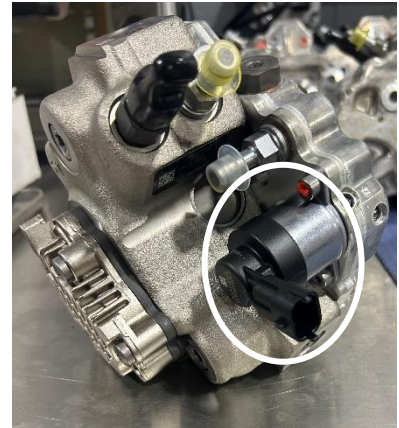
**Fuel Control Actuator (FCA):** The fuel control actuator regulates fuel from the CP3 to the high-pressure fuel rail and is located on the rear-facing side of the CP3. The FCA can also be called REG 1. Incorrect wiring or faulty connections can cause a no start condition. The connector should have a yellow wire and a black wire.

| Step 7 | Are all electrical connections to the CP3 and high-pressure fuel system correct? For the FCA and Regulator 2, refer to page 6 of this document. Verify that the fuel temperature sensor on the cascade block is connected and that all harness connections are properly made. Are all electrical connections correct? | If yes, proceed to step 9 | If no, proceed to step 8 |

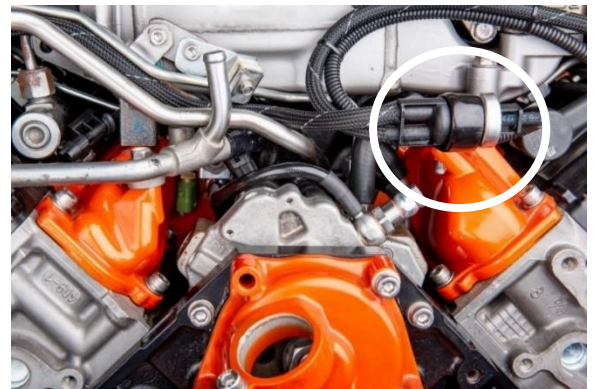
**Fuel Injector Return Regulator:** The fuel injector return regulator is a constant pressure regulator and does not have any electrical connections. The return system requires at least 4 bar (58 psi) to be present before the injectors will begin working. If the return system cannot reach 58 psi when starting the engine, the return lines and regulator will need to be replaced. This component will normally be located near the thermostat housing on the engine. Image at right does not show the installed location.

GM Injector Return Lines and Regulator: P/N 12639000

| Step 11 | Pressurize the return fuel system by connecting a test port to the 9 <sup>th</sup> injector and pressurize the system with shop air. If the vehicle starts, replace the injector return lines and regulator (GM P/N 126390000). | | |
